Manhole Inspection Summary

Manhole # S07AA2023MH

Insp Date: **9/20/06 9:50 AM**

Location Address: **5910 CROSS COUNTRY BLVD** Cross Street: **WESTERN RUN DR**

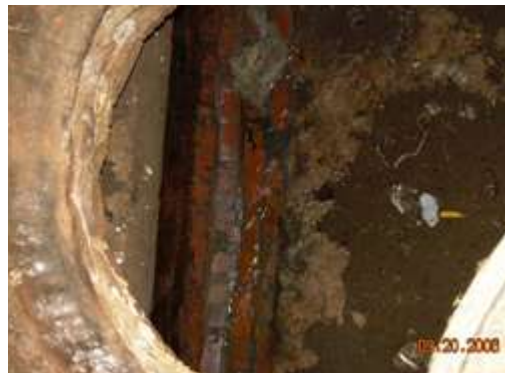
Top View

Frame leaks. Adjustment infiltration.
Evidence of surcharge - Bench debris.
Channel debris.

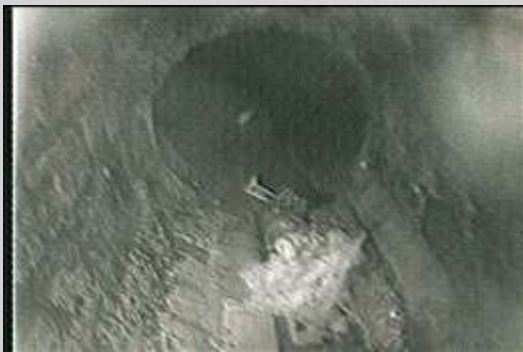
12 in. Circular Gravity Sewer Pipe Out @ 12 O'Clock

Infiltration: **Evidence** Pipe Seal Cond: **Cracked**

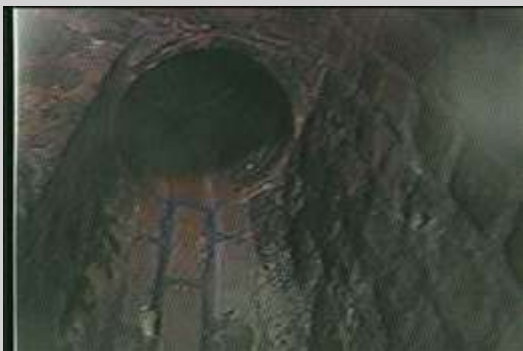
12 in. Circular Gravity Sewer Pipe In @ 6 O'Clock

Infiltration: **Evidence** Pipe Seal Cond: **Cracked**
